BY: <b>Rolando Ionta</b>	DATE: <b>15-Mar-00</b>
CHK'D:	DATE:
Project No. <b>YY-XXX</b>	
Description: <b>Client Name Here</b>	
<b>Blast Furnace- Bull Wheel Bearing Failure Review</b>	
Report e-mailed to "Mr. XXXX" on mm/dd/yr.

### Conclusions of Field Inspection and Observations:

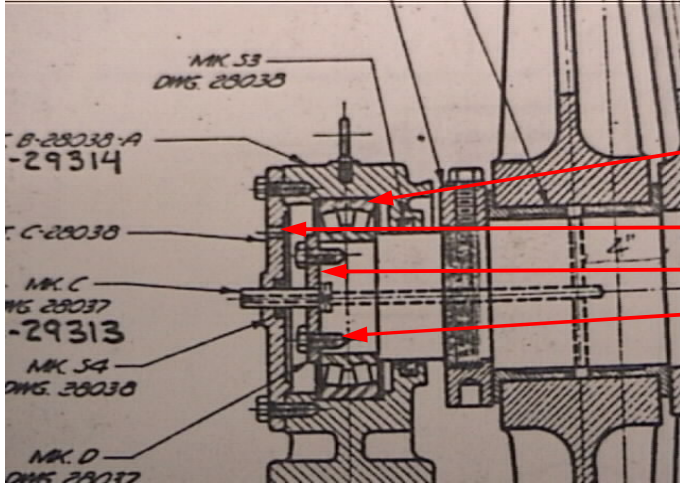
**PHOTO No. 1**

This is a portion of drawing "XXXXX" depicting the bearing assembly.  
 No. 22230 double row spherical roller bearing.  
 Grease hole for bearing.  
 Bearing Retainer.  
 4 Cap Screws for bearing retainer.

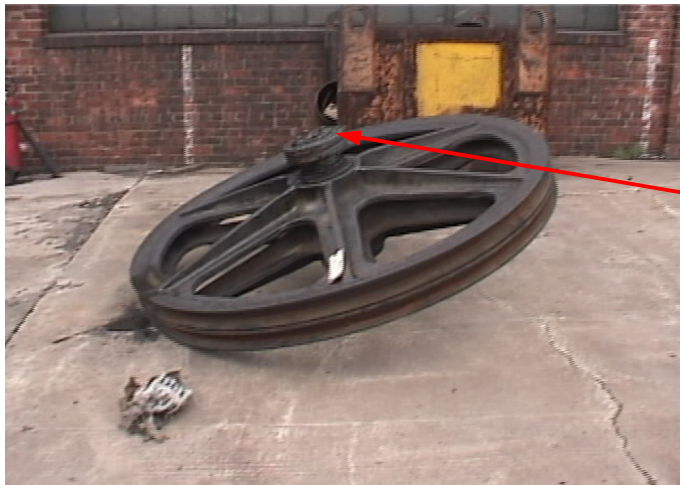
**PHOTO No. 2**

This is a photo of the failed Southwest Bull Wheel located behind Station "XXX".  
 Notice that one bearing is still in place.  
 The shaft end of the failed bearing is resting on the ground and not visible in this photo.

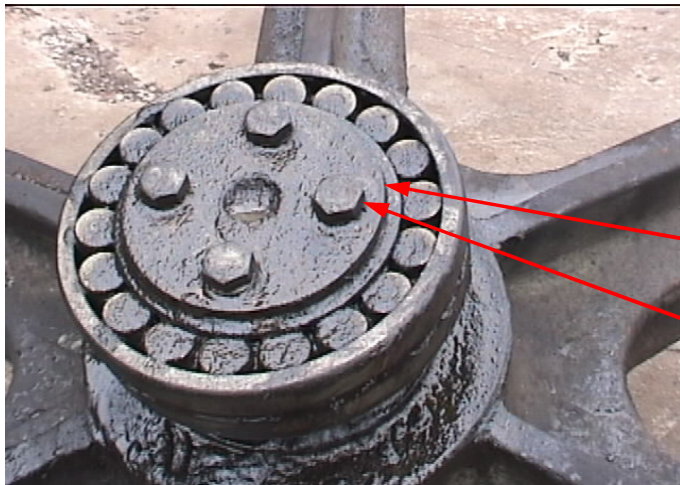
**PHOTO No. 3**

Closer view of the bearing shown in photo 2 above. This is a double row spherical roller bearing.  
 Notice the Bearing Retainer.  
 Notice the Four (4) bearing retainer Hex Head Cap Screws.

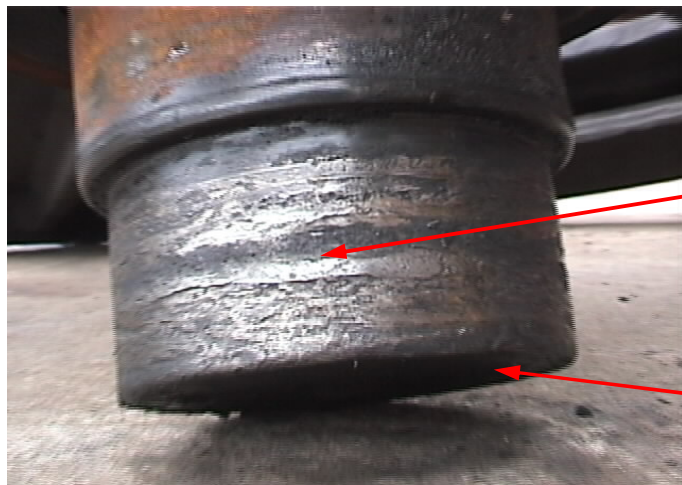
**PHOTO No. 4**

This photo depicts the shaft end of the failed bearing.

Notice the severe GALLING and discoloration.  
See photo 5 for a closer view.

Although not visible in this photo, there are 4 sheared retainer cap screws in the shaft.

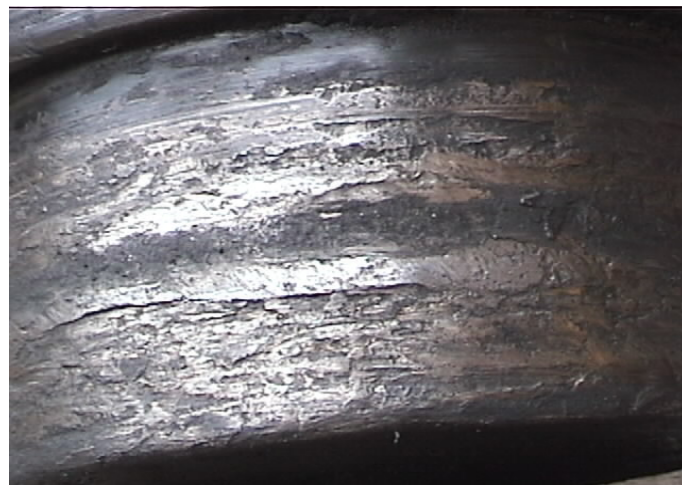
**PHOTO No. 5**

This is a close-up view of the shaft shown in photo 4 above.

Notice the severe GALLING, which is a physical displacement of metal due the inner race of the bearing spinning on the shaft.  
Notice the discoloration of the shaft which depicts overheating.

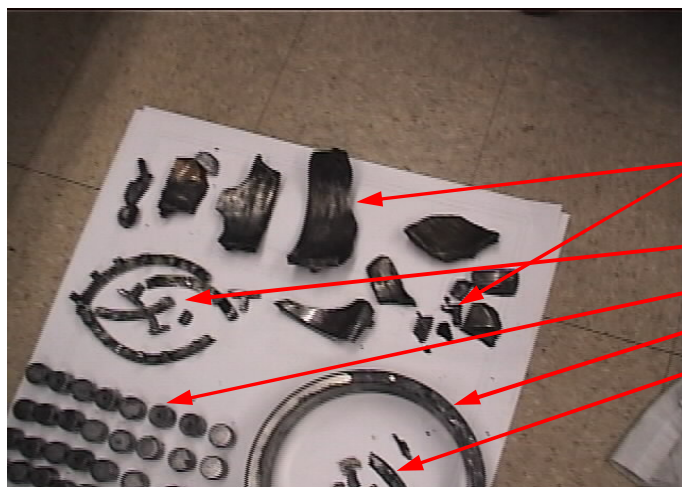
**PHOTO No. 6**

This photo depicts the failed bearing components laid out for visual examination.  
Inner bearing race fragments. Range from 1/2" to 6" long fragments.  
Roller cage fragments.  
Spherical Rollers (34 rollers).  
Outer bearing race.  
Outer bearing race fragments. Range from 3/4" to 2 1/4" long fragments.  
Not shown in photo, 3 retainer cap screws.

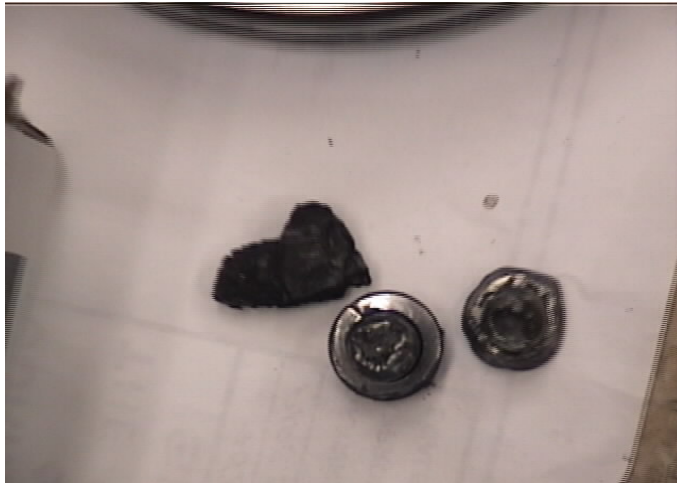
**PHOTO No. 7**

This photo depicts the three (3) retainer hex head cap screws of the failed bearing. Not shown in photo 6.

All three cap screws are severely damaged to varying degrees.

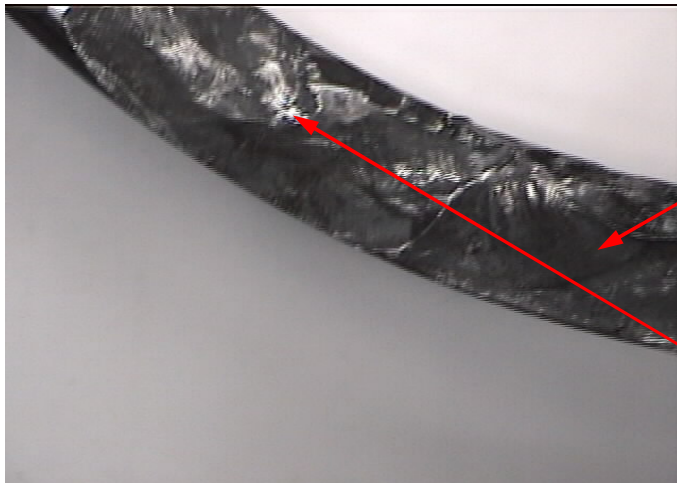
**PHOTO No. 8**

This is a close-up view of the fractured edge of the outer bearing race.

The clean fracture surface indicates a sudden failure sending "Splintered" pieces within the bearing housing.

The smooth, polished surfaces indicate that the retainer was being worn by part fragments during operation.

- 2- The cracked outer rim and hot spots indicate that the bearing housing may have been distorted thereby not providing proper support of the bearing. This is typically what causes cracks in the outer rim.

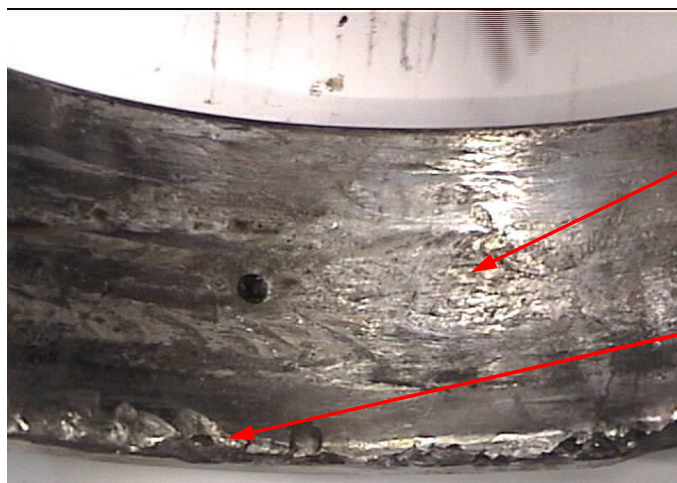
**PHOTO No. 9**

Close-up view of the roller contact surface of the outer race.

Notice severe flaking, spalling and denting of the rolling surface indicating a rather sudden catastrophic failure.

Notice the fractured but polished edge indicating that broken pieces, grit or other debris or contamination created a "Polishing" effect during operation.

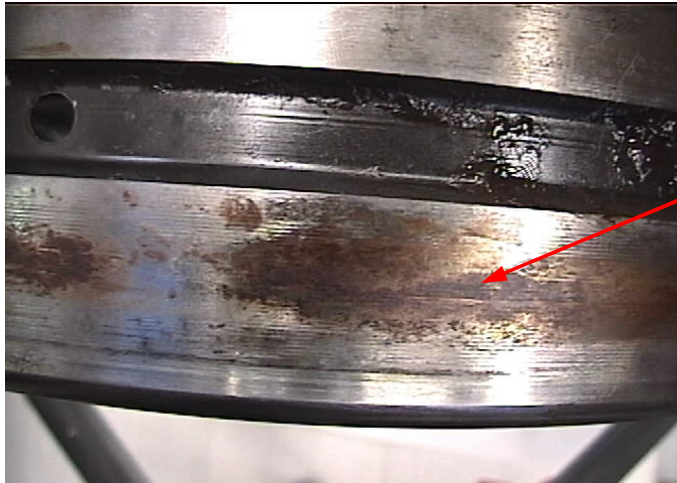
**PHOTO No. 10**

This is a close-up view of the outside surface of the outer bearing race.

Notice the patches of discoloration and spin marks on the circumference of the outer race.

This indicates that the outer race was moving/slipping within the housing and was also subjected to hot spots.

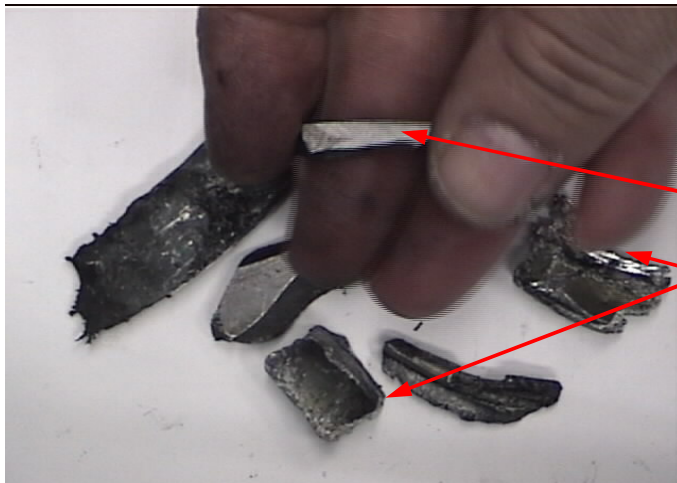
**PHOTO No. 11**

This photo depicts some of the "Splintered" pieces of the outer race ranging in size from 3/4" to 2 1/4" long.

Some pieces are clean sudden fractures, as that held in hand, with no signs of wear.

Other pieces are severely worn and polished. Very small slivers of magnetic metal were also observed to be suspended within the grease still on the bearing fragments.

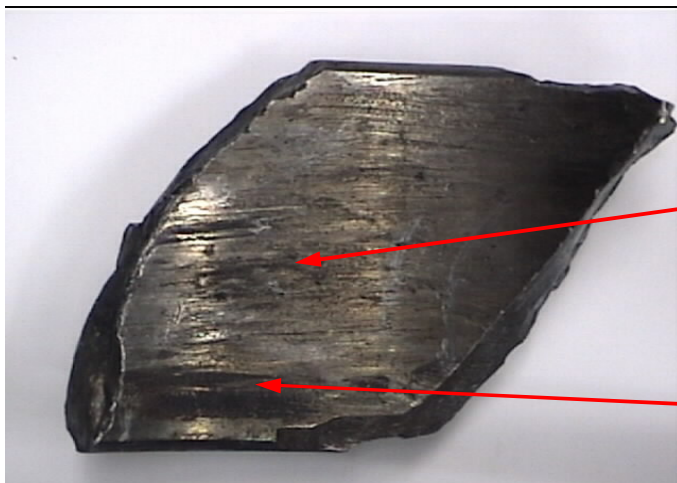
**PHOTO No. 12**

This photo depicts a fragment of the bearing inner race.

Notice the signs of slipping/rotation on the shaft mating surface. This generated the extreme heat and galling of the shaft depicted in photos 4 and 5 above.

Notice the discoloration depicting the high heat from friction.

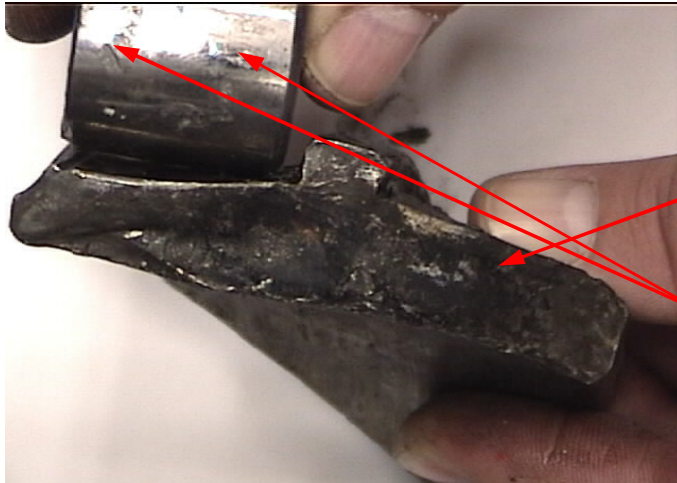
**PHOTO No. 13**

This is a close-up end view of the inner bearing race shown in photo 12 above.

Notice the severe discoloration.

Notice how the spherical roller would fit on the race.

Notice the severe denting and spalling on the roller.

The remaining grease on the inner race had magnetic slivers suspended within it.

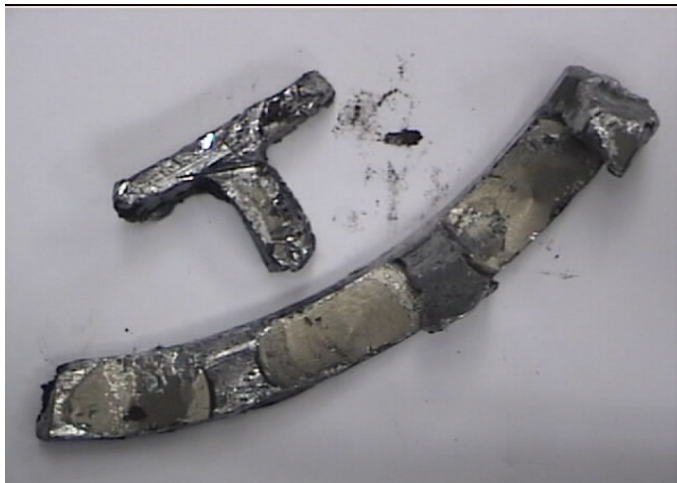
**PHOTO No. 14**

This photo depicts fragments of the bearing roller cage.

These pieces depict severe wear marks.

These pieces were observed to be extremely light in weight. When tested with a magnet, they were not magnetic.

This cage is probably aluminum.

**Roller cages for severe service bearings are typically made of brass or steel.**

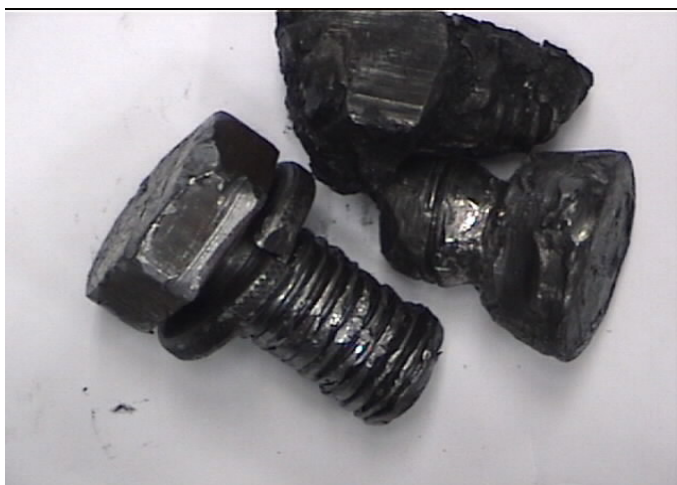
**PHOTO No. 15**

This is a photo of 3 out of the 4 bearing retainer cap screws. All of the cap screws were sheared off at the shaft end.

The cap screws show varying degrees of wear and polishing. These cap screws were tumbling around within the bearing housing for some time after they sheared off the shaft.

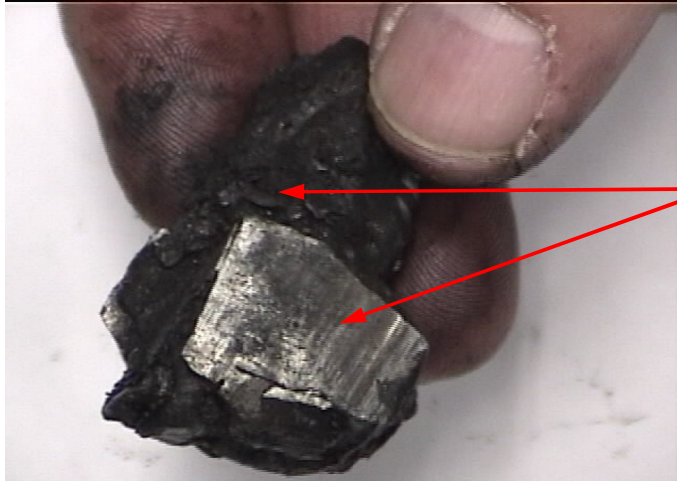
**PHOTO No. 16**

This photo depicts the most severely worn retainer cap screw.

Notice the severe wear marks from being ground up by moving parts within the bearing housing.

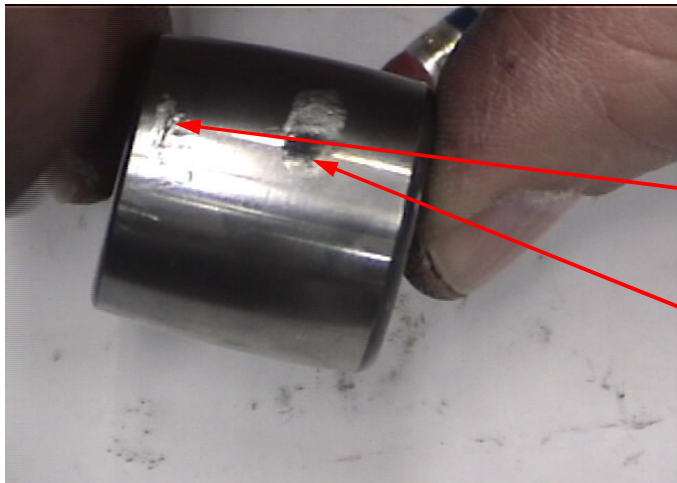
**PHOTO No. 17**

This is a photo of one of the spherical rollers.

Notice indentations which is due to foreign matter in the bearing.

This patch on the roller is physical metal removal due to sliding of the roller during initial seizure.

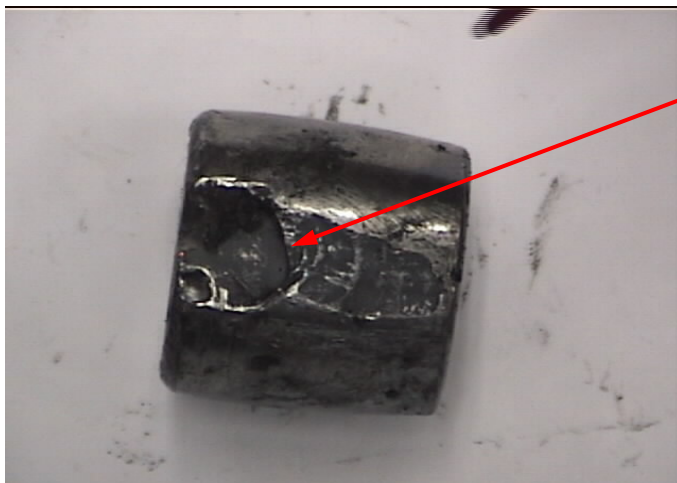
**PHOTO No. 18**

This photo depicts a spherical roller with a relatively large section of the roller surface just literally broken away.

This is not due to wear but, rather, due to a sudden failure due to foreign particle/s within the bearing rolling surfaces.

There is no discoloration due to heat.

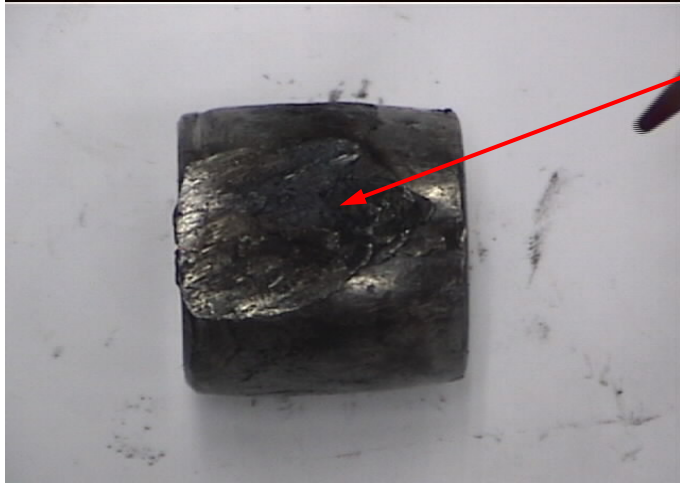
**PHOTO No. 19**

This photo depicts a roller with extreme discoloration and a large rough area where the roller was sliding during advanced seizure of the bearing. The bearing components were extremely hot at this point. Softening of the bearing races and rollers occur at this point which appreciably accelerates wear.

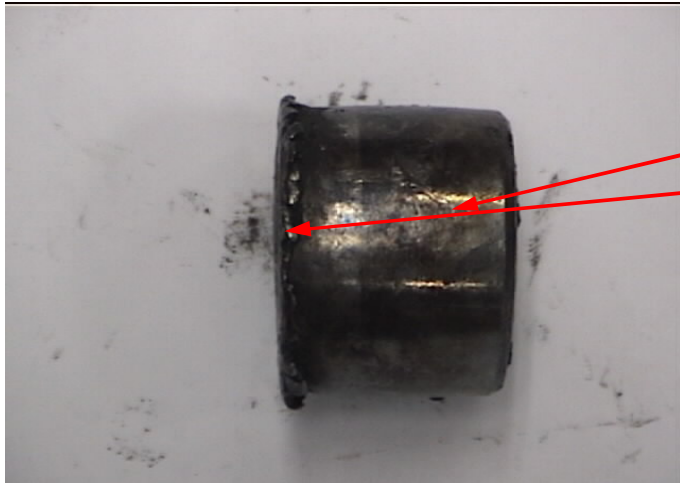
**PHOTO No. 20**

This photo depicts wear on a spherical roller for an appreciably long time. The roller is very discolored. One edge of the roller is severely worn, mushroomed and discolored due to softening of the metal due to extremely high heat.

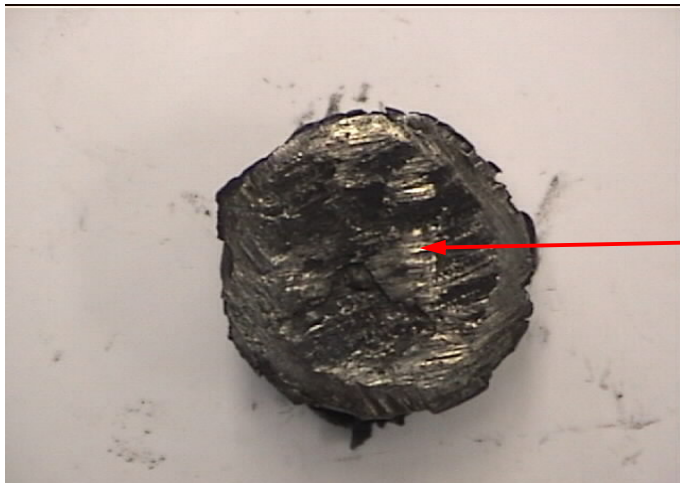
**PHOTO No. 21**

This photo depicts the mushroomed end of the spherical roller shown in photo 20 above. Notice the severe wear marks on the end of this roller. This roller was subjected to physical wear from moving parts for a long time.
