BY: Rolando Ionta	DATE: 29-Mar-00
CHK'D:	DATE:
Project No. YY-XXX	
Description: Client Name Here	
Crane Drive Inspection & Repair Recommendations	
Report e-mailed to "Mr. XXXX" on mm/dd/yr.

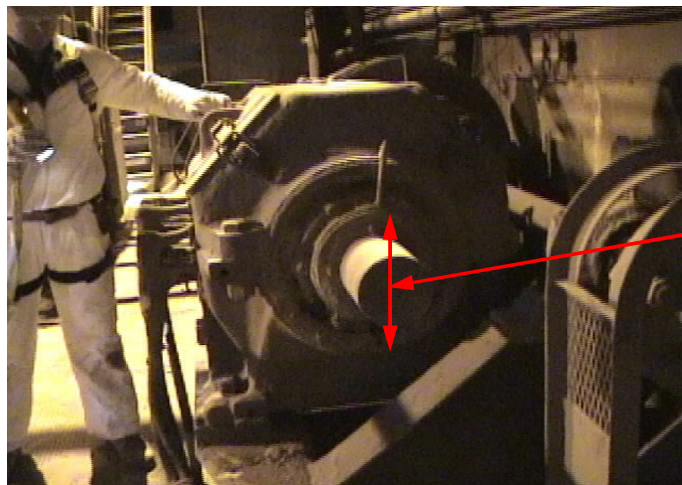
PHOTO No. 1

General Photo looking west at the south bridge drive during NO LOAD test operation.

The whole drive assembly was observed to have significant vertical movement during acceleration and deceleration.

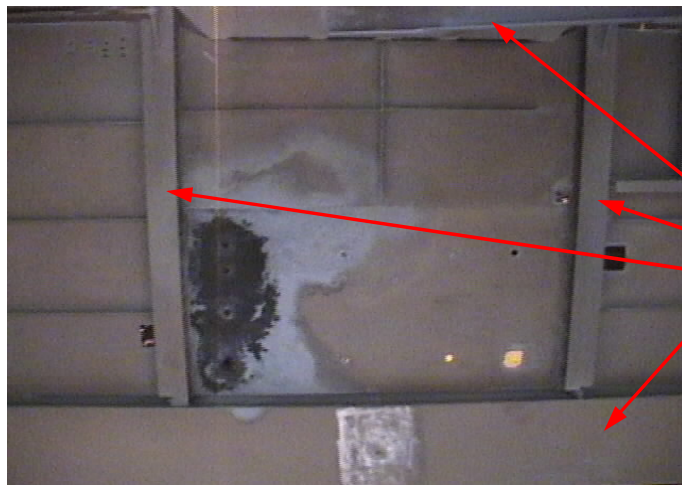
PHOTO No. 2

This is a photo looking up at the south bridge drive support beams from under the walkway. Walkway Truss, on south end of crane.
 East drive support beam.
 West drive support beam.
 South Bridge Girder.

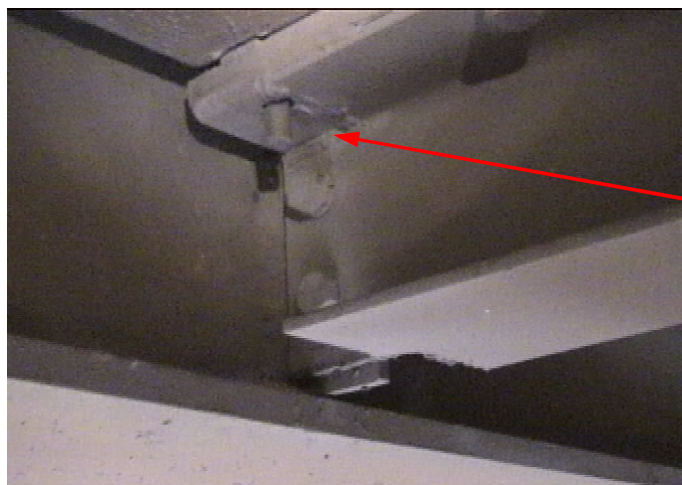
PHOTO No. 3

This is a view looking at the north end of the east beam. Notice the following.

- 1- Nut missing on bolt.
- 2- Previous repair weld has cracked.
- 3- Crack in weld has propagated into beam web base metal.

- 1- Repair the crack on the north end of the east beam as shown in photos 3, 4 and 5.
- 2- Repair the crack in the northwest corner of the motor mounting base plate as shown on the marked-up print and section X-X by adding:
 - a- Stiffener bar- ITEM NO. 1
 - b- Reinforcing angle- ITEM NO. 2
 - c- Beam Stiffener- ITEM NO. 4
- 3- Stiffen entire west side by adding stiffener bar- ITEM NO. 1
- 4- Repair crack in motor mounting plate shown in photos 6 and 7 in accordance with instructions on marked-up print.
- 5- Repair top flange of support beam shown in photos 6 and 7 by adding a reinforcing angle as shown on marked-up print section Y-Y; ITEM NO. 3.
- 6- Install 3 beam stiffeners on east beam- ITEM NO. 4
- 7- Replace all drive mount bolts with new grade 5 or A325 bolts.

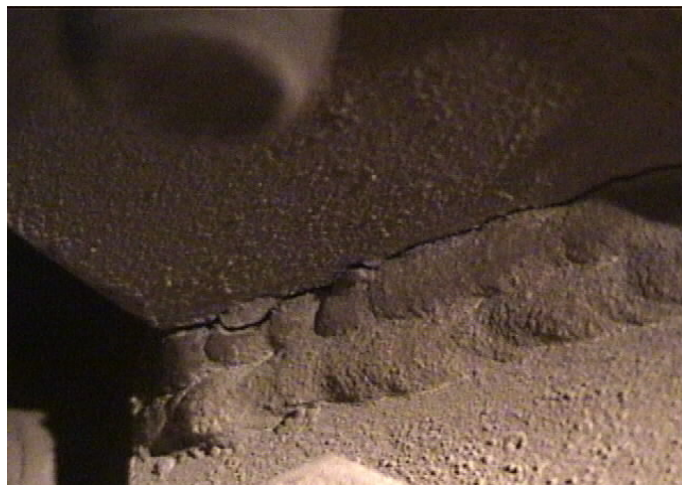
**PHOTO No. 4**

Close up view of photo 3 above depicting the crack in existing repair weld.

Repair: Gouge out and re-weld.

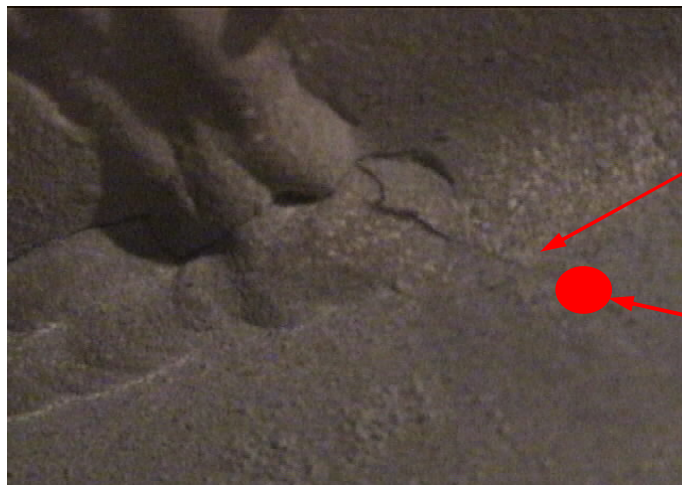
**PHOTO No. 5**

This is a continuation of the crack shown in photo 4 above.

The crack in the weld has propagated into the beam web base metal.

**Drill 1/2" relief hole at end of crack.
Gouge out crack and re-weld.**

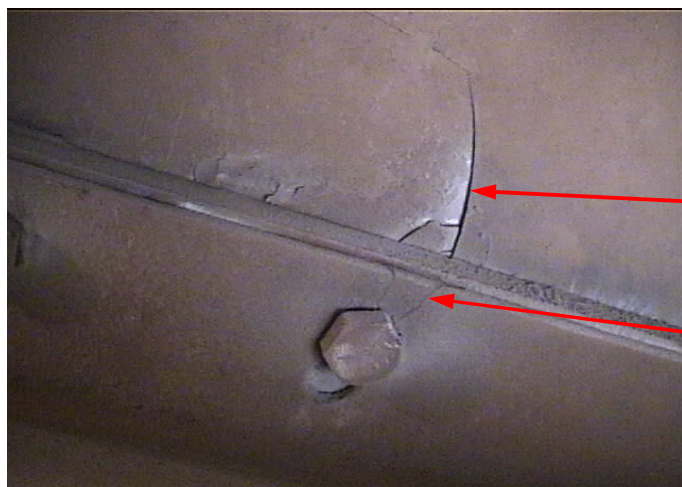
**PHOTO No. 6**

View looking at extreme south connection on the east drive support beam.

Motor mount base plate is severely cracked.

Portion of support beam flange is completely cracked through.

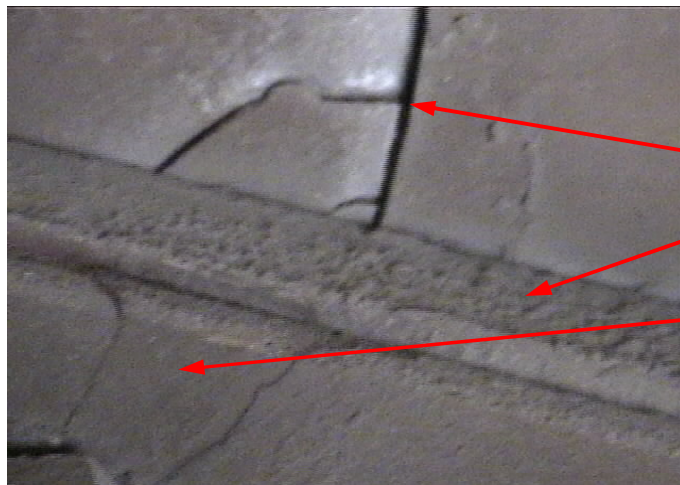
**PHOTO No. 7**

Close-up view from photo 6.

Severe crack in motor mount base plate.

Spacer bar is not damaged.

Portion of support beam flange is completely cracked through.
