BY: Rolando Ionta	DATE: dd-mm-yy
	CHK'D: Bogdan Mazurczyk	DATE: dd-mm-yy
	Project No. YY-XXX	
	Description: Blast Furnace- Small Bell Lift Chain Eyebolt Failure Analysis	
	This report e-mailed to Client staff on dd/mm/yy

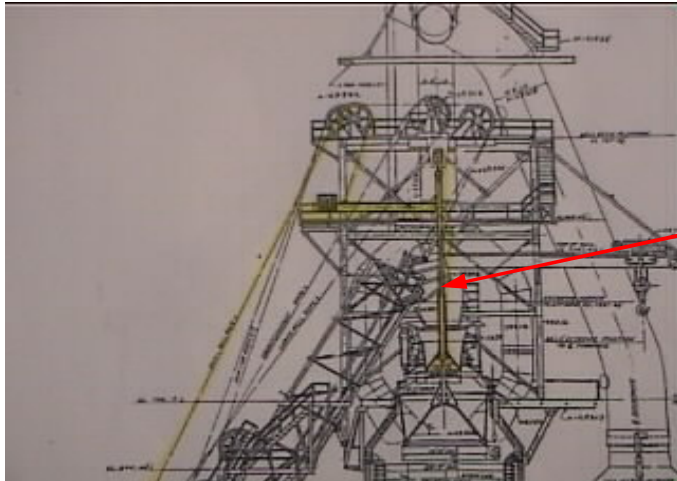
PHOTO No. 1

Partial view of Section A-A on Drawing XXX. Small and Large Bell are actuated by wire ropes from a hoist in the Skip Hoist Room.

Small Bell is highlighted in yellow.

Small Bell Eyebolts failed on Saturday, mm/dd/yy.

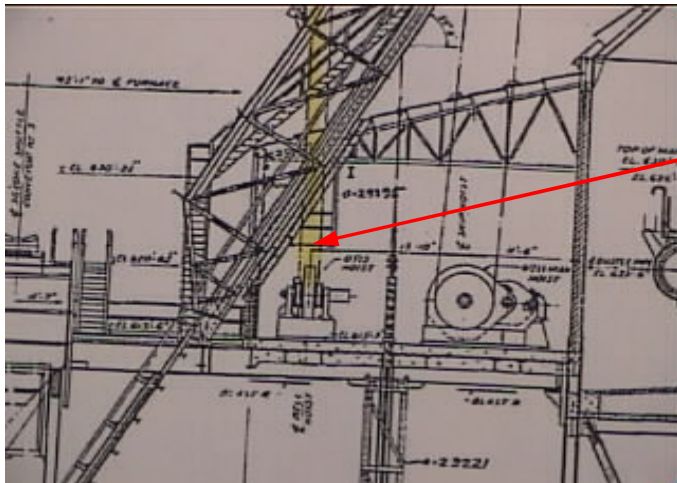
PHOTO No. 2

Partial view of Section A-A on Drawing XXX. Small and Large Bell are actuated by wire ropes from a hoist in the Skip Hoist Room.

Small Bell ropes are highlighted in yellow.

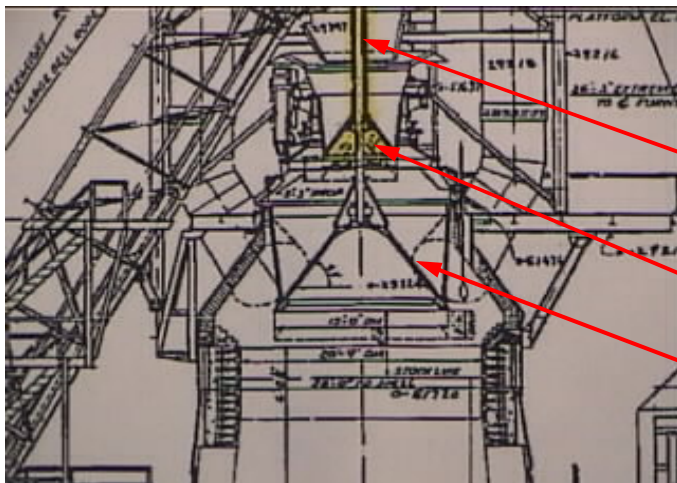
PHOTO No. 3

Closer view of Section A-A on Drawing XXX.

Bell Rod- Large Bell Rod operates within the small bell rod.

Small Bell is highlighted in yellow.

Large Bell.

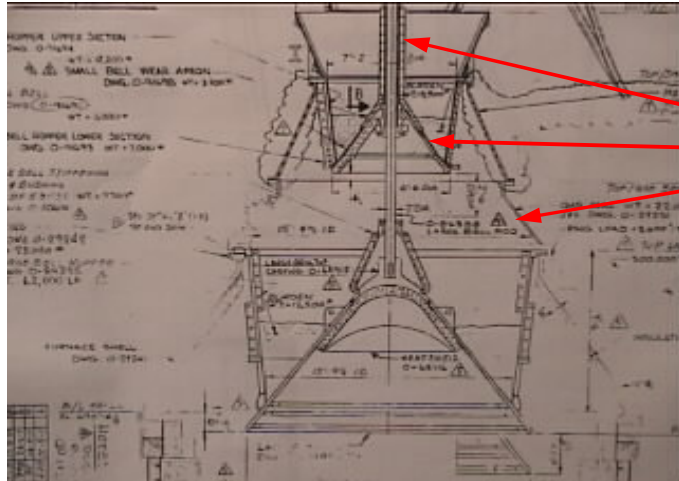
PHOTO No. 4

Partial view of Drawing XXX.
 Small Bell Rod.
 Small Bell.
 Gas Seal- space between small and large bell. This space must be equalized to operate large bell. The equalizing pressure is 7 PSIG. This space must be relieved/vented to operate the small bell.
 Small Bell cycles 5-6 times per large bell cycle.

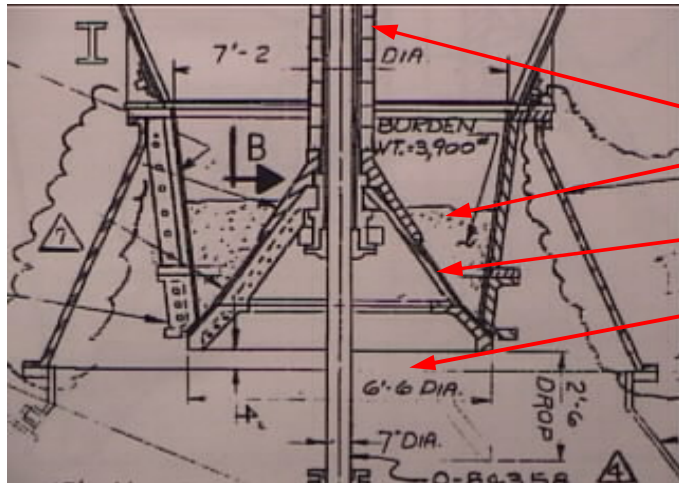
PHOTO No. 5

Partial view of Drawing XXX.
 Small Bell Rod.
 Typical Burden Load= 3,900 Lbs.
 Maximum Burden, full hopper= 22,000 Lbs.
 Small Bell.
 6'-6" (78") Small Bell diameter.
 At 7 PSIG equalizing pressure, Small Bell with Burden can be supported with lifting beam in open position.

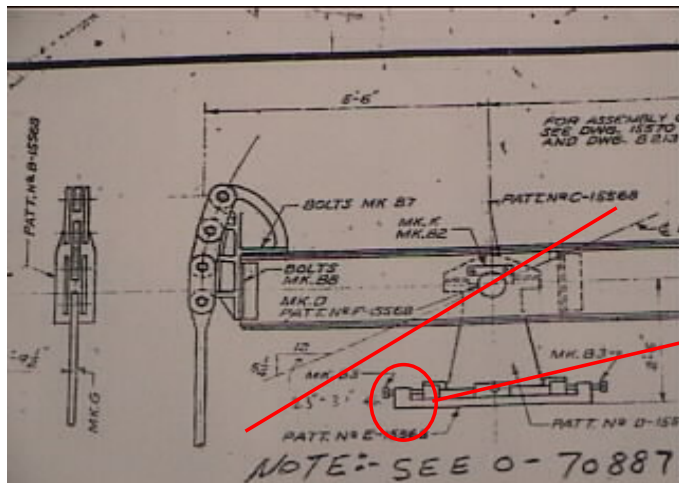
PHOTO No. 6

Partial view of Drawing XXX.
 Normal actuation of lifting beam yields 2-3" of vertical motion at approx. 23.6° beam pivot.
 Lift beam will bottom on support if driven down by free falling small bell.
 Lift beam will bottom at approx. 30° beam pivot yielding approx. 34 1/2" of vertical travel of the small bell assembly.

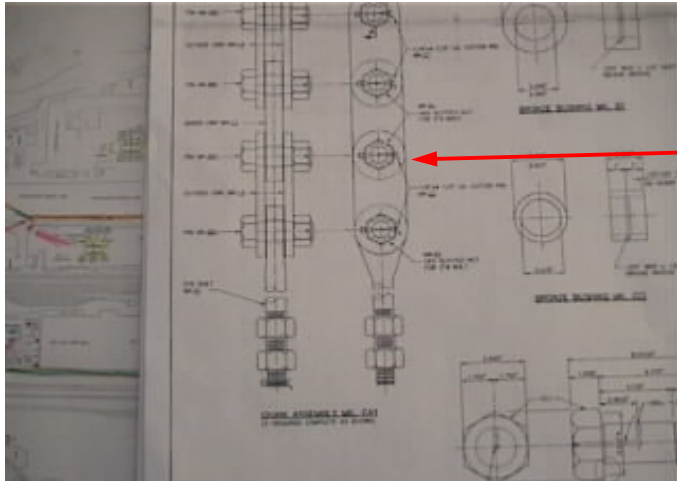
PHOTO No. 7

Partial view of Drawing XXX.

Lift Chain assembly is attached to the lifting beam shown in Photo 6 above.

See Photo 8 for view where lift chain attaches to the Small Bell Support.

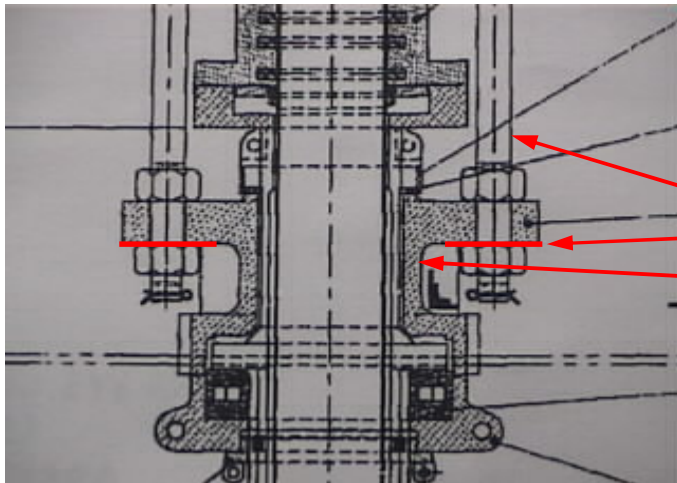
PHOTO No. 8

Partial view of Drawing XXX.

This is the connection of the lifting chain assembly to the Small Bell Upper Support.

Failed Eyebolt MK-E1

Eyebolt Failure Planes.

Small Bell Upper Support.

The assembly is visually leveled and adjusted making equalizing of the load very difficult. Design is not self equalizing.

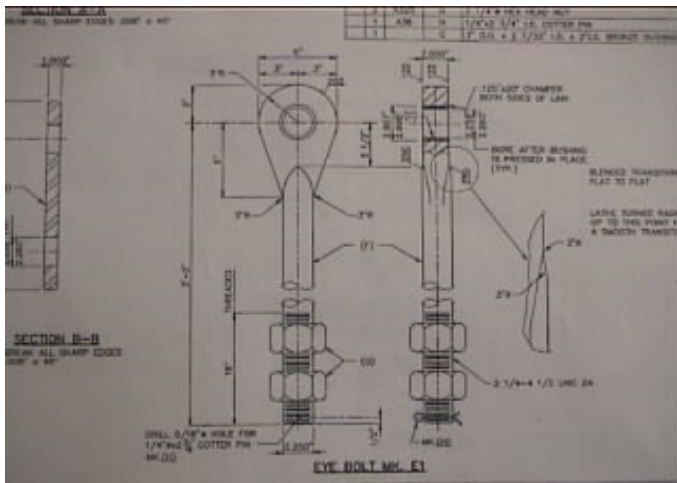
PHOTO No. 9

View of Eye Bolt MK-E1 on Drawing XXX.

Except for the fracture, the two failed eyebolts were per dimensions on drawing.

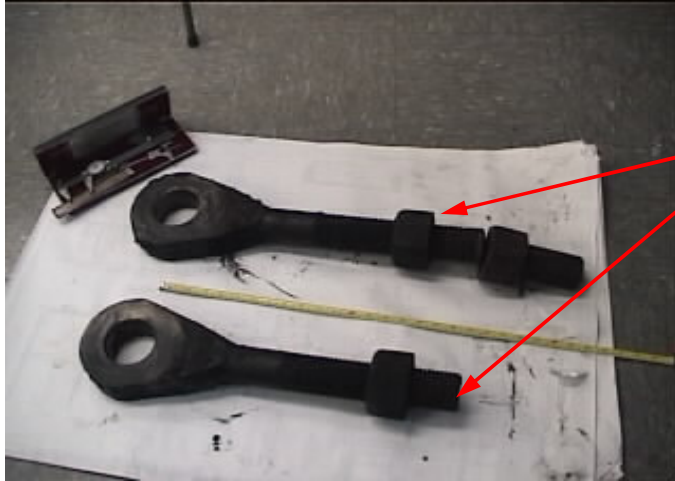
**PHOTO No. 10**

View looking at the failed eyebolts from the mm/dd/yy Failure.

North Eyebolt with fractured mating part.
South Eyebolt- mating part not found.

North eyebolt measured 18 3/4" from center of eye to fracture.

South eyebolt measured 19 1/4" from center of eye to fracture.

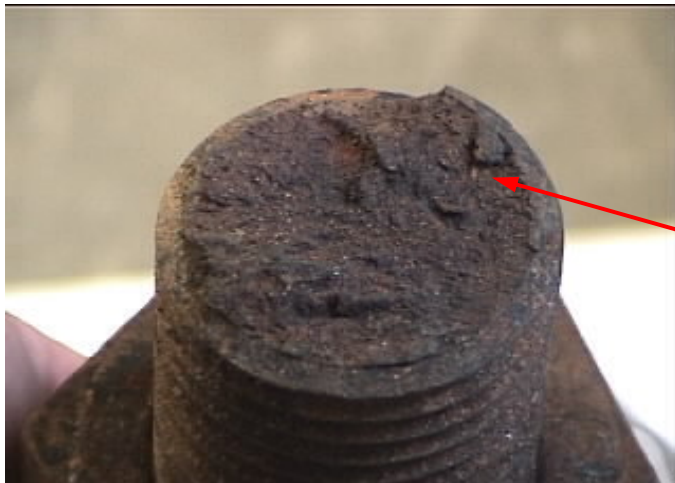
**PHOTO No. 11**

Close-up view of the south eyebolt fracture surface. Observations are as follows:

- 1- Very rough failure surface across entire root diameter.
- 2- Shear Lip.
- 3- No beach (Fatigue) marks present.
- 4- No signs of necking.

This is typical of a sudden overload failure of a brittle material which indicates that this is a very tough material as specified.

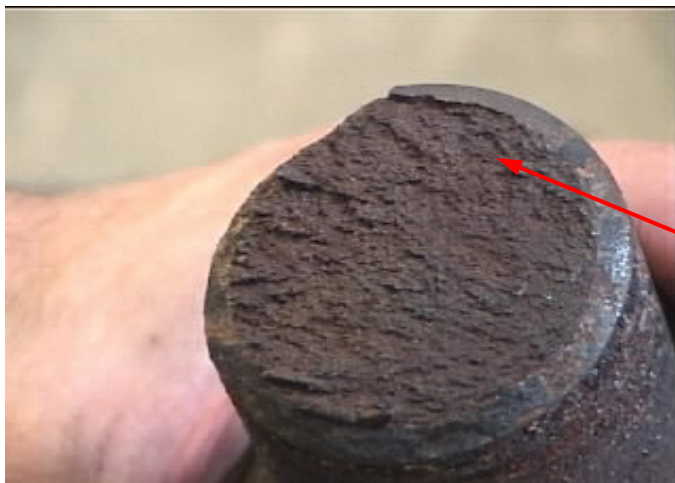
**PHOTO No. 12**

Close-up view of the north eyebolt fracture surface. Observations are as follows:

- 1- Very rough failure surface across entire root diameter.
- 2- Shear Lip.
- 3- No beach (Fatigue) marks present.
- 4- No signs of necking.

This is typical of a sudden overload failure of a brittle material which indicates that this is a very tough material as specified.

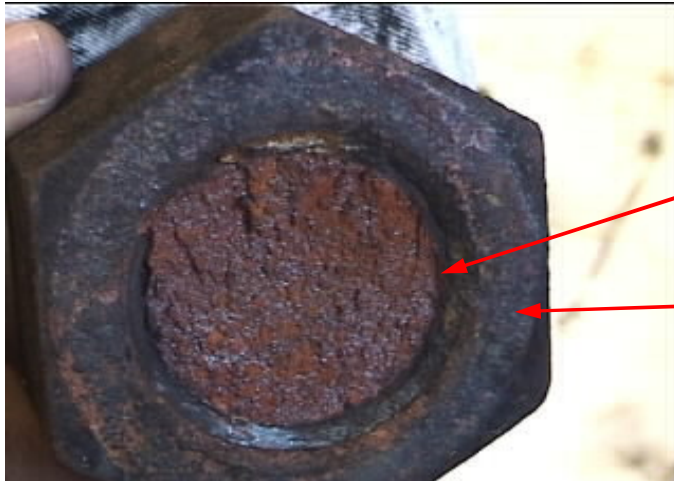
**PHOTO No. 13**

Close-up view of the mating part of the north eyebolt fracture surface. Observations are as follows:

- 1- Failure surface is a direct match with that of the north eyebolt shown in photo 12 above.
- 2- No abnormal signs on the nut.
- 3- Washer surface of all three nuts are very corroded. This may be an indicator of poor seating which would also indicate one eyebolt was subjected to entire load.

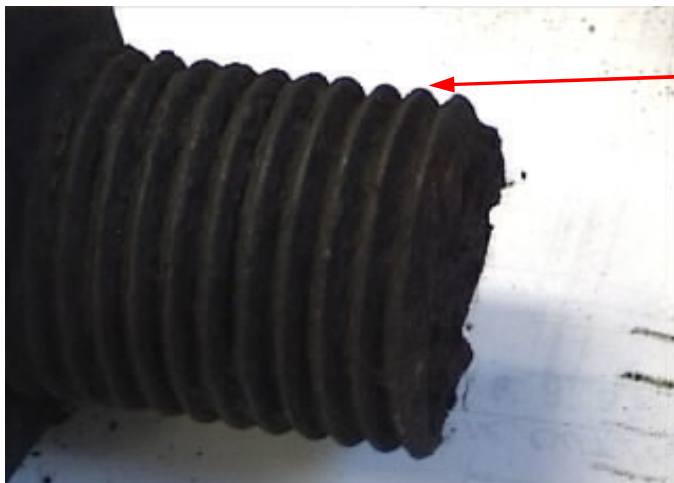
**PHOTO No. 14**

Close-up view of the outside diameter of the threads at the failure plane.

Observations are as follows:

- 1- No sign of necking.
- 2- No sign of any stretched threads.

This is typical of an overload failure of a brittle material which indicates that this is a very tough material as specified.

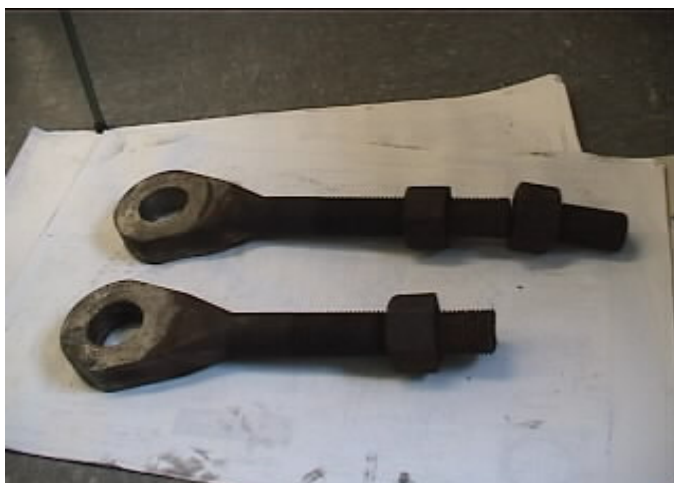
**PHOTO No. 15**

Both of the failed eyebolts were re-inspected after cleaning. There were no deficiencies observed except for the fractures in the threads. The eyebolts were straight indicating no major side or bending forces.

Both eyebolts were then sent to Client LAB for hardness testing and metallurgical analysis.

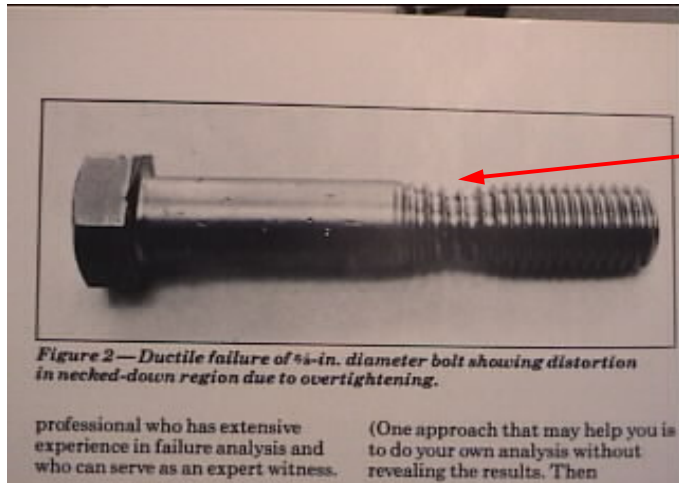
PHOTO No. 16

Photo of reference information for diagnosing bolt failures.

This photo depicts sudden overload of a ductile material which results in **necking** or yielding of the material.

This is not what was observed on the two subject eyebolts. Therefore, the two subject eyebolts are not ductile but brittle as is typical of high strength materials.

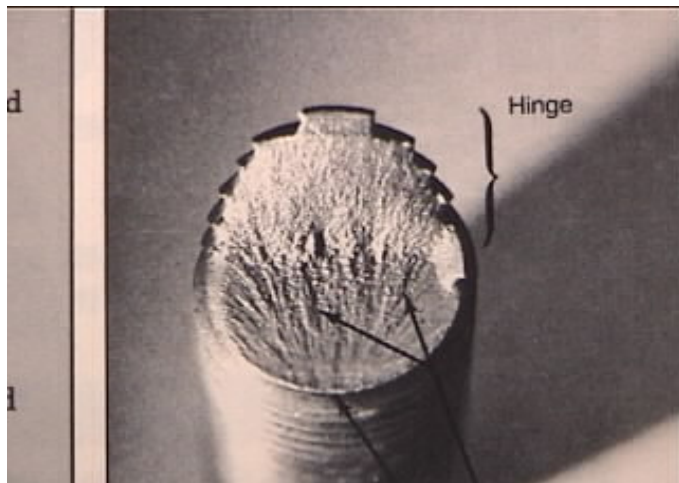
PHOTO No. 17

Photo of reference information for diagnosing bolt failures.

This photo depicts sudden overload of a brittle material.

This is similar to the failure observed on the two subject eyebolts. Therefore, the two subject eyebolts are not ductile but brittle as is typical of high strength materials.

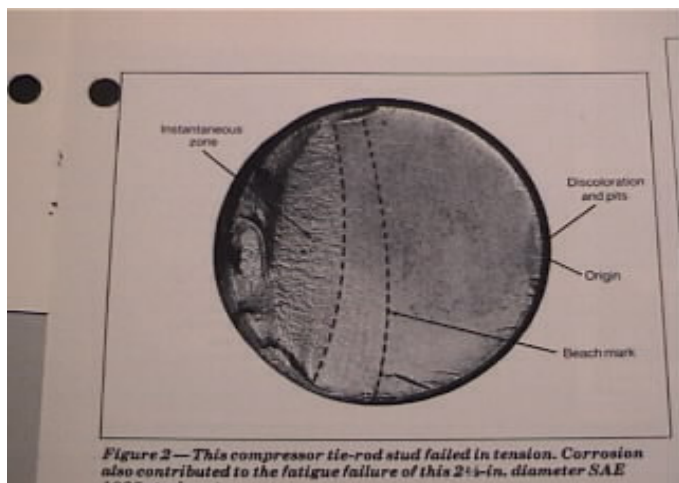
PHOTO No. 18

Photo of reference information for diagnosing bolt failures.

This photo depicts a fatigue type of failure.

This is not what was observed on the two subject eyebolts. There were no beach or fatigue lines on the two failed eyebolts, but, rather, one large instantaneous failure zone was present depicting a sudden overload.

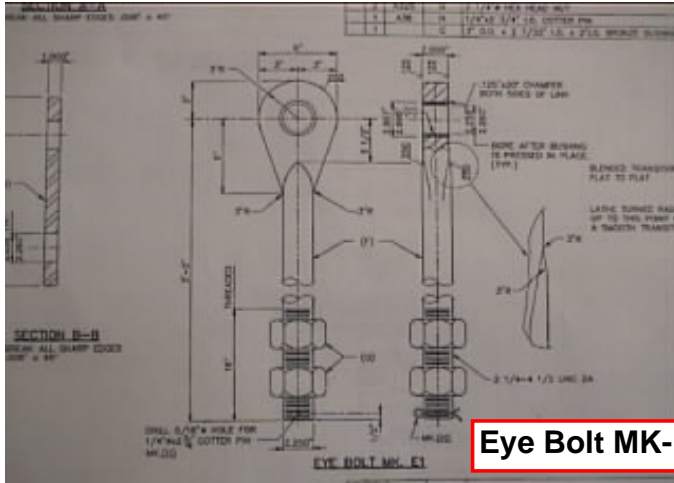
Eye Bolt MK-E1

From the above analysis of the lifting chain components, the Eye Bolt MK- E1 is by far the weakest component in this mechanism with the weakest point being at the root of the threads.

Please note that stress concentration factors can vary significantly depending on the exact geometry of the thread profile. Stress concentration factors for threads are typically in the range of 2 to 4 and sometimes can be significantly higher. For this analysis, a stress concentration factor of 3 was used which is a typical average value.

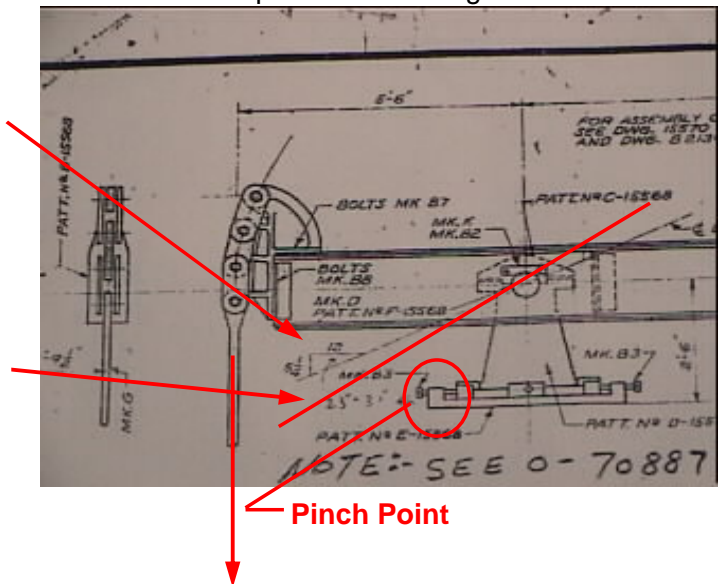
Calculate the energy developed by the small bell free falling the distance resulting from the lift beam bottoming out on the bracket/support underneath it as depicted on drawing 0-XXX as shown below.

The 5 1/4 to 12 slope shown on the dwg. equates to the 2'-3" drop specified on the dwgs.

However, should the small bell rod free fall, the beam can pivot up to a maximum angle of approximately 30° per the layout shown.

At approximately 30° the vertical free fall drop is calculated to be:

Max Drop = 34.56 inches
