Project No. YY-XXX

Description: Client Name Here

Lifting Beam Emergency Inspection & Repair Recommendations

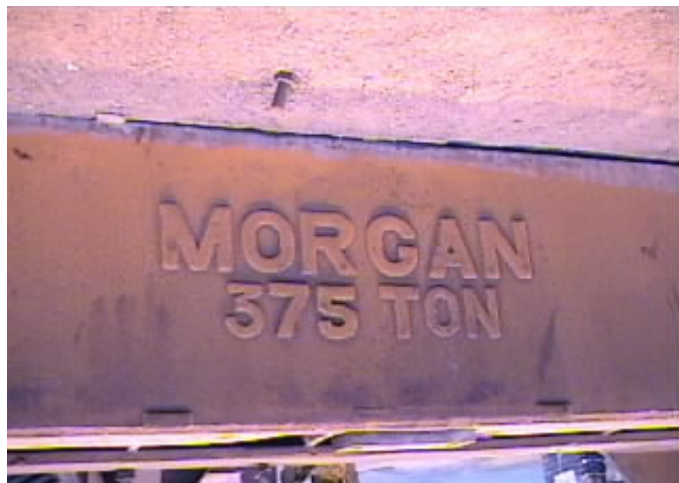
**PHOTO No. 1**

This is a general view of the 375 Ton Lifting Beam used on the Charging Crane. This photo was taken upside down to depict the lifting beam markings. The subject lifting beam is depicted on Client drawing XXXX-1. The drawing specifies the material to be A.S.T.M. A-242 for the main load members, which is a Low Alloy High Strength material also known as COR-TEN A.

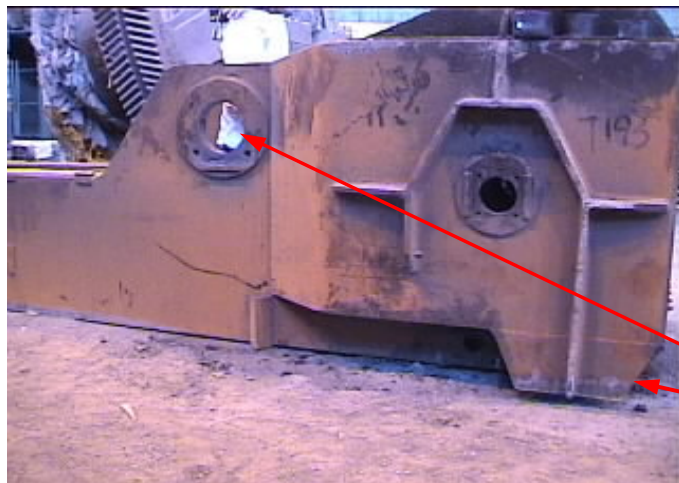
**PHOTO No. 2**

General view of the Crane Lifting Beam at start of the visual inspection.

Bores for hook adaptor pins.
Top of side plate on far side is bent, see photos 4, 5 & 6 for details.

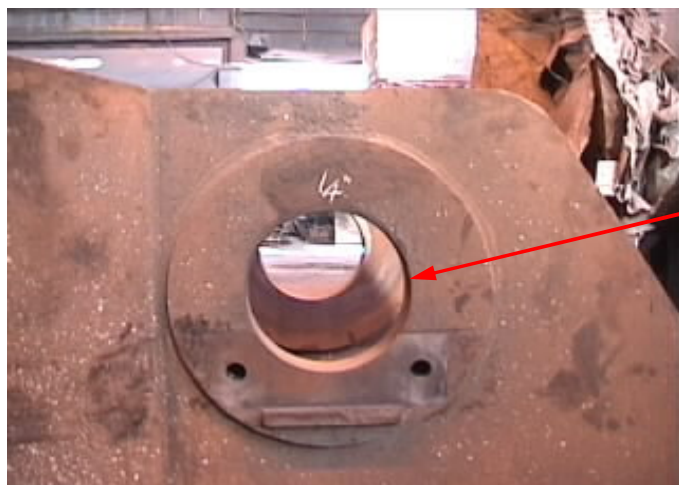
**PHOTO No. 3**

Close-up view of one of the bores for the hook adaptor pins. There are a total of four (4) bores. All four (4) bores are vertically elongated approximately 1/4".

Repair- Line Bore existing bores to accommodate a new bushing, Stitch weld four (4) bushings in place.

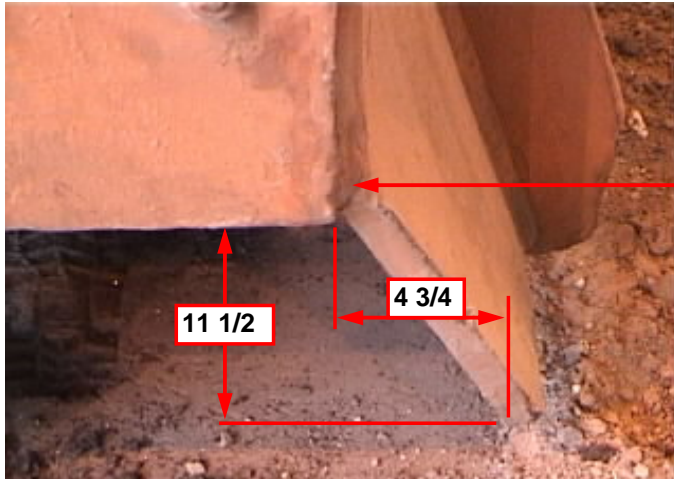
**PHOTO No. 4**

Close up view showing a bent vertical side plate in one of the top corners of the lifting beam.

A 2" long crack through the weld is also present in the corner.

- 1- Heat side plate & stiffener.
- 2- Straighten side plate & Stiffener.
- 3- Gouge out cracked weld and re-weld, see photo 5.

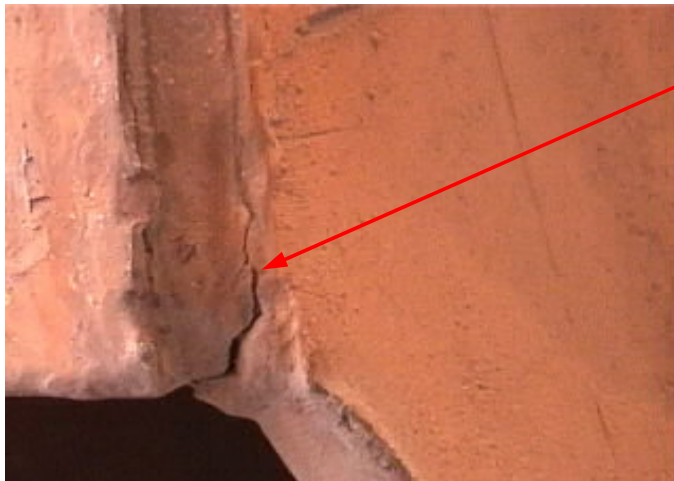
**PHOTO No. 5**

Closer view of the 2" long crack in the weld depicted in photo 4. The crack is visible on both sides of the weld. The crack does not extend into the base metal.

Repair weld per attached standard repair procedures.

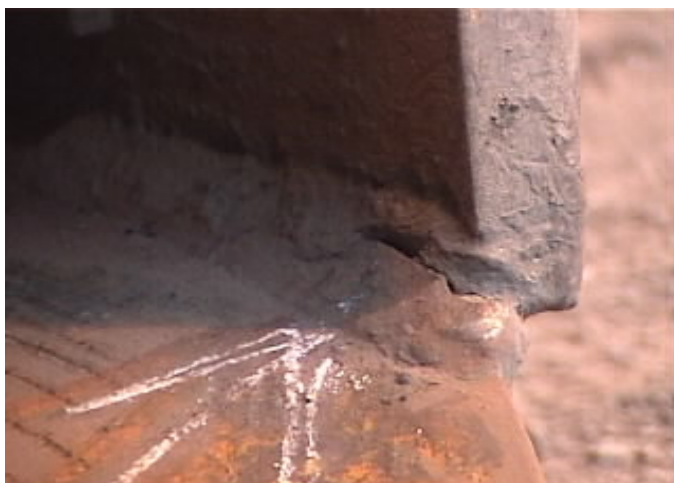
**PHOTO No. 6**

Close up view of the opposite side (inside of the lifting beam) of the cracked weld depicted in photos 4 and 5 above.

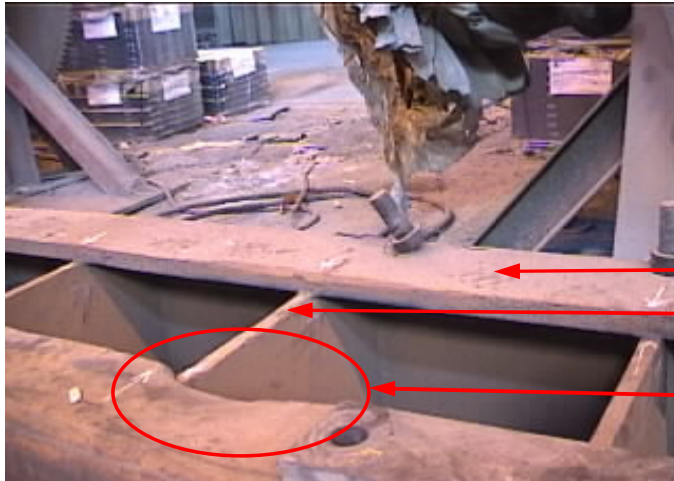
**PHOTO No. 7**

General view looking at bottom flanges and diaphragm plates. 5 of the 7 diaphragm plates are cracked in the weld and base metal.

Bottom Flange- 1 1/2" COR-TEN A.
Diaphragm Plate- 1" A7 or A283.

Notice 9"L x 4"W x 1 1/4" deep depression in bottom flange from being pinched/struck.

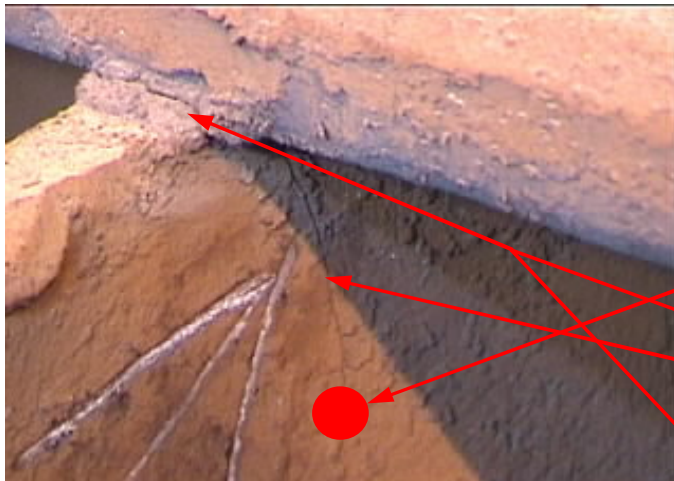
**PHOTO No. 8**

Close up view of the cracked weld and diaphragm plate.

- 1- Locate end of crack in diaphragm plate.
- 2- Drill 1/2" relief hole at end of crack.
- 3- Grind off cracked fillet weld.
- 4- Back gouge and weld per attached repair procedures.
- 5- Re-weld 3/8" fillet weld.

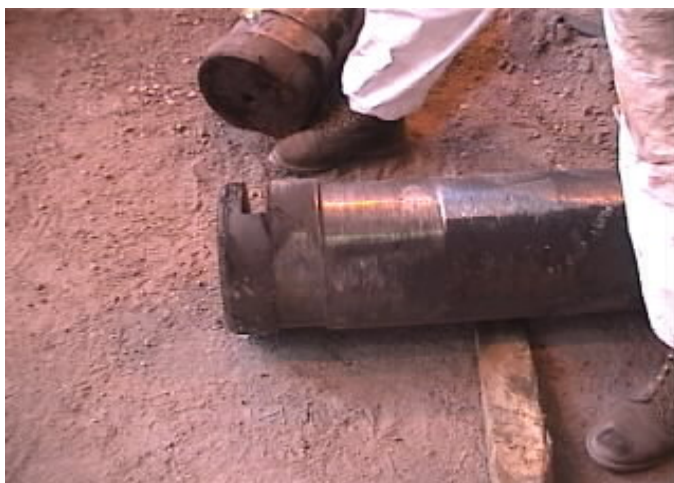
**PHOTO No. 9**

General view of the two 10 1/2" pins that fit into the elongated bores depicted in photos 2 and 3 above.

Both pins are severely worn beyond repair.

Repair- Replace both pins in kind.

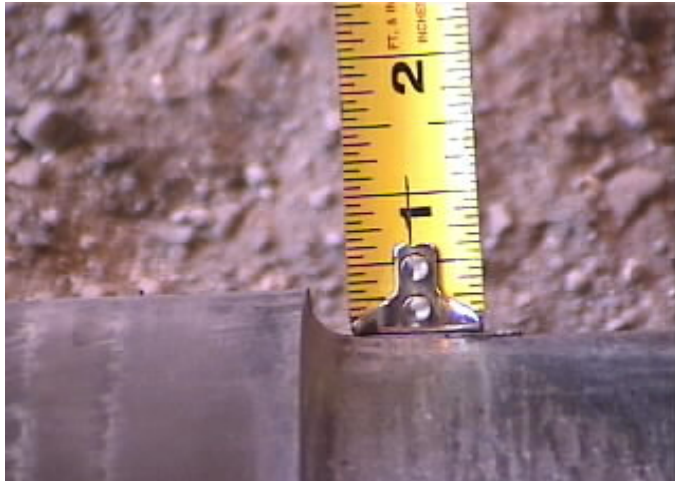
**PHOTO No. 10**

Close up view of the worn step in the pins shown in photo 9 above.

There is a nominal 3/8" step worn into these two pins.

Repair- Replace both pins in kind.

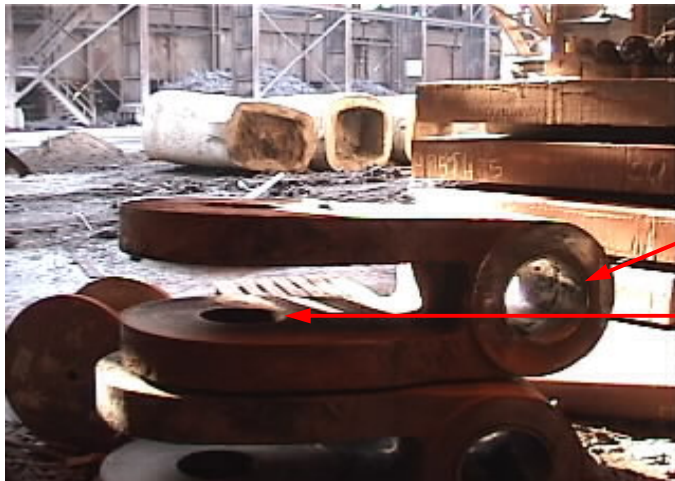
**PHOTO No. 11**

General view of the ladle hook adaptor used to connect the ladle hook to the lifting beam.

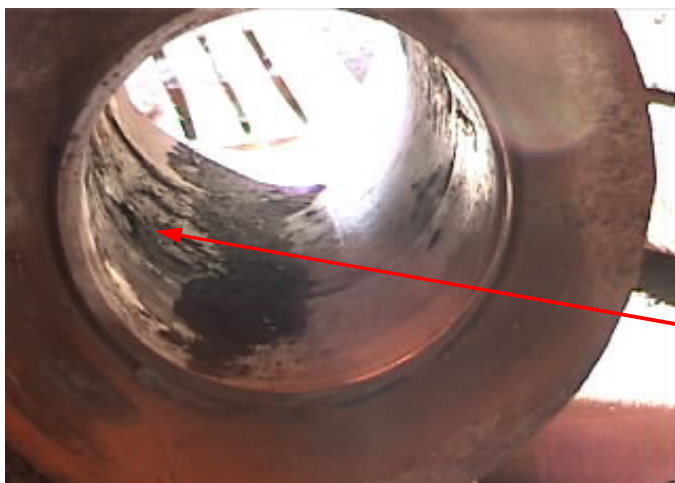
**PHOTO No. 12**

Close-up view of the 10 1/2" bore for the lifting beam pins in the adaptor shown in photo 11 above.

Inside/bore of bushing is severely galled.

Repair:
Closely inspect all bushings for wear and/or cracking. Replace bushings in sets as required.

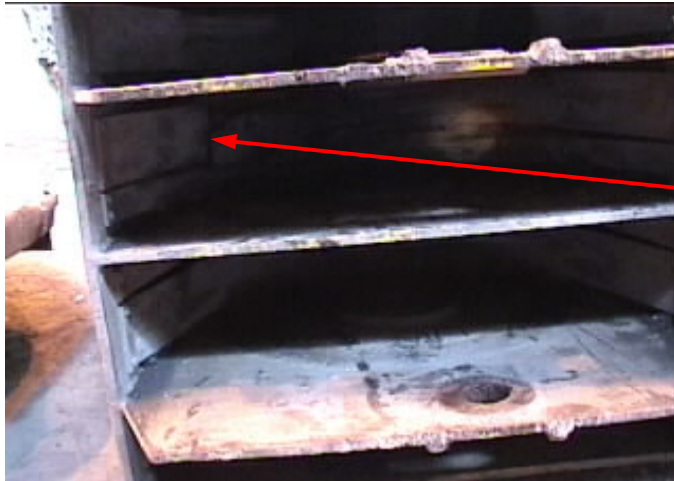
**PHOTO No. 13**

General view of lifting beam sheave pockets on opposite end of the bent side plate depicted in photo 4.

The sheave guards in the center pocket are severely worn and cracked (not depicted in photo due to lighting).

Replace sheave guards in center pocket in kind.

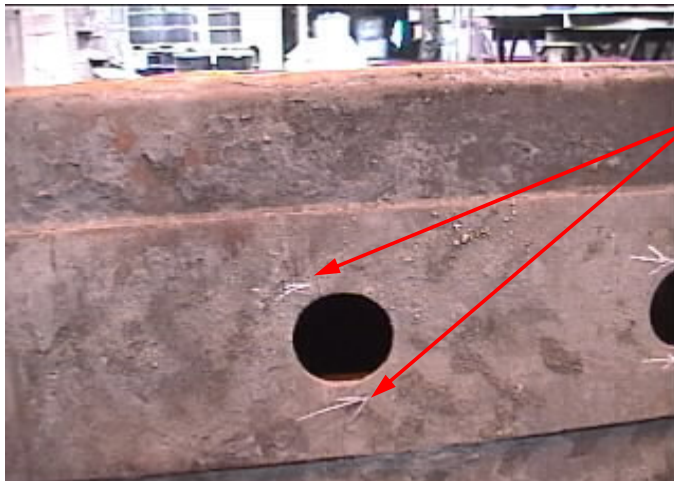
**PHOTO No. 14**

General view of the 3/8" top cover plate.

Seven out of the eight 6" diameter burned clearance holes have radial cracks starting at the inside edge of the hole and propagate out towards the fillet weld.

Since the top flange is normally in compression, this type of failure mode indicates that the lifting beam was subjected to torsional loading due to some type of abnormal loading condition.
