BY: Rolando Ionta	DATE: dd-mm-yy
	CHK'D: Bogdan Mazurczyk	DATE: dd-mm-yy
	Project No. YY-XXX	
	Description: Blast Furnace- Small Bell Lift Chain Eyebolt Failure Analysis	
	This report e-mailed to Client staff on dd/mm/yy

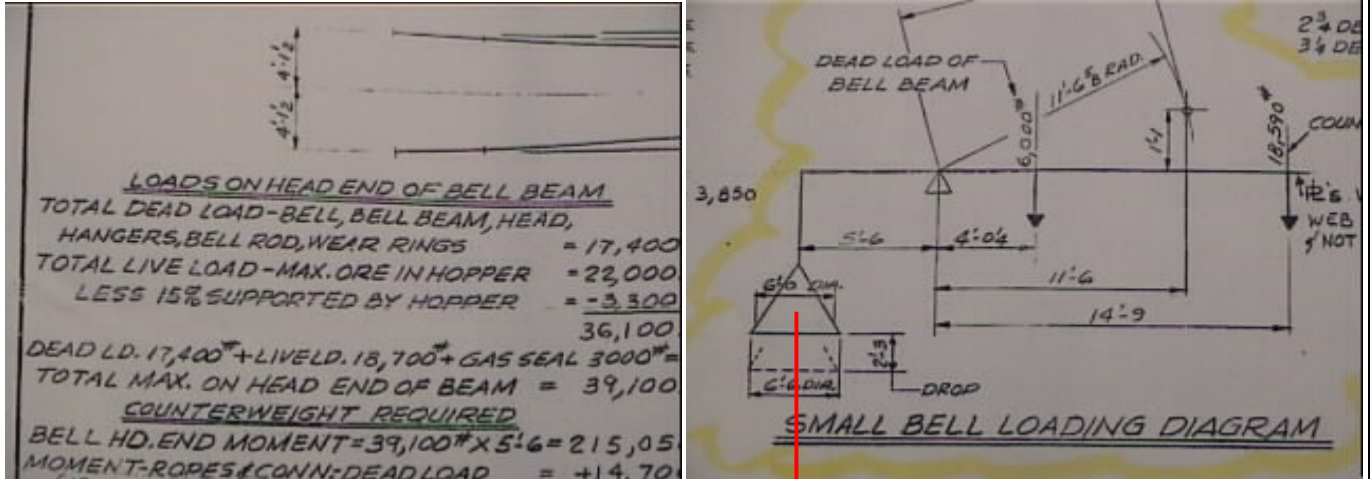
Small Bell loading data is specified on Client Drawing 0-XXX, see photos below.
